CHANGES AND ADDITIONS TO BULLETIN 1108B, ISSUE 2 BULLETIN 1126B, ISSUE 2 PARTS - MODEL 14 REPERFORATOR TRANSMITTER

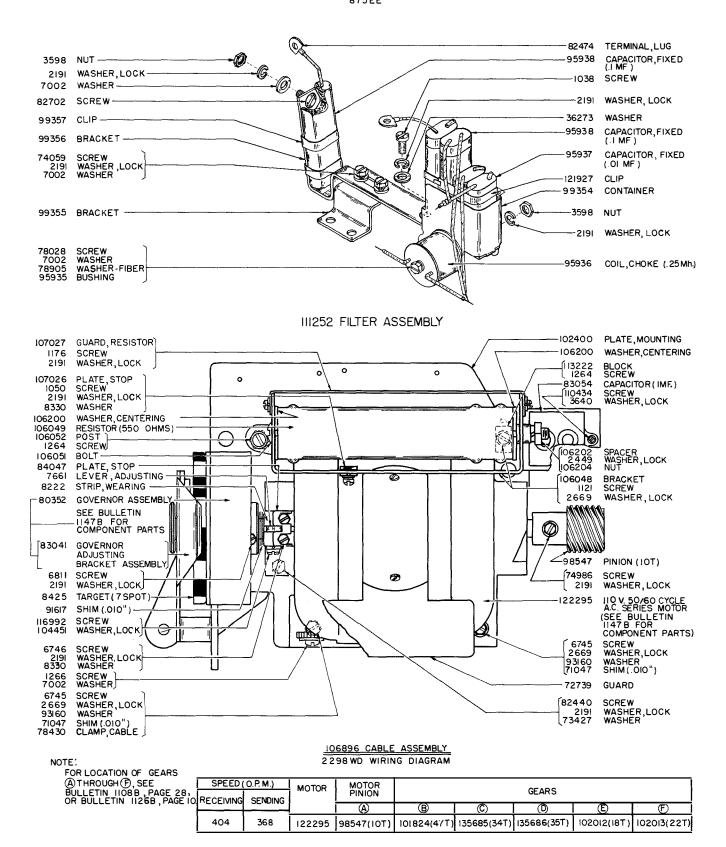
The 135687 governed motor arrangement with gears for receiving at 404 opm and sending at 368 opm is illustrated in Figure 1 of this correction sheet.

135687 A.C. GOVERNED MOTOR ARRANGEMENT (WITH GEARS FOR 404 QPM RECEIVING AND 368 OPM SENDING)

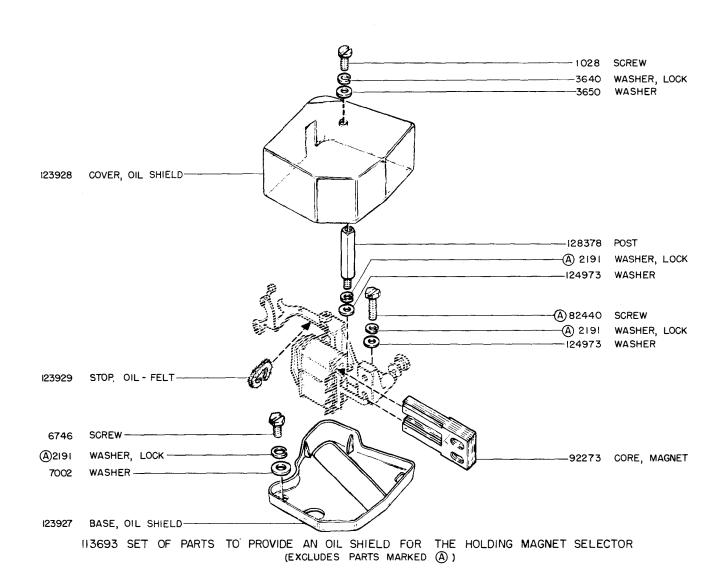
FIGURE 2

See Figure 2 for the revised illustration of the 113693 set of parts to provide an oil shield for the holding magnet selector.
