INSTRUCTIONS FOR INSTALLING THE 194244 MODIFICATION KIT TO PROVIDE AN IMPROVED TAPE SUPPLY ARM FOR HIGH SPEED REPERFORATOR TRANSMITTER TAPE HANDLING STANDS LTHS202 AND LTHS209

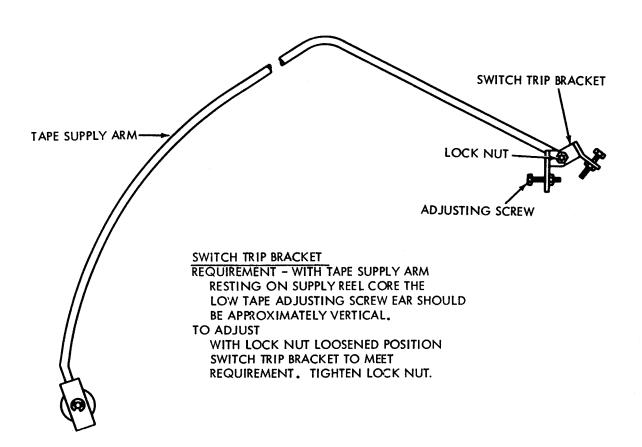
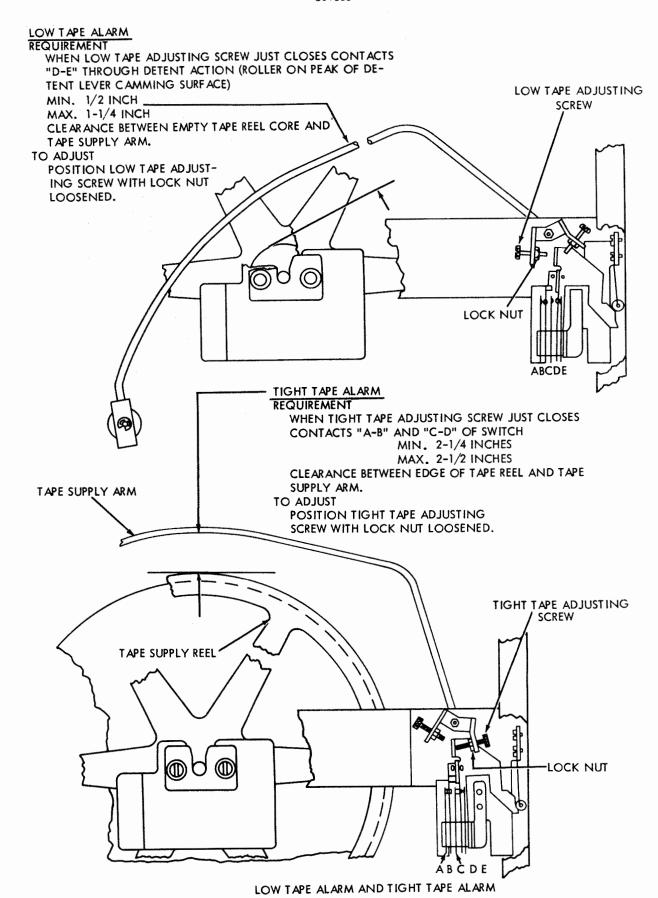
FIGURE 2.

- a. The 194244 Modification Kit provides an improved tape supply arm which eliminates erratic operation of the tight-tape alarm switch on LTHS202 and 209 Units.
 - b. The 194244 Kit consists of:

- a. For standard adjustments and lubrication procedure of related equipment see Teletype Bulletin 248B.
 - b. Make the adjustments given on the attached figures.
