### TAPE LID SPRING ADJUSTMENT FEED WHEEL DETENT SPRING ADJUSTMENT

APPARATUS AFFECTED: 1A and 2A Tape Readers — DATASPEED.

## TP149989 BRACKET AND TP149990 NUT PLATE

#### SECTION 592-801-700.02

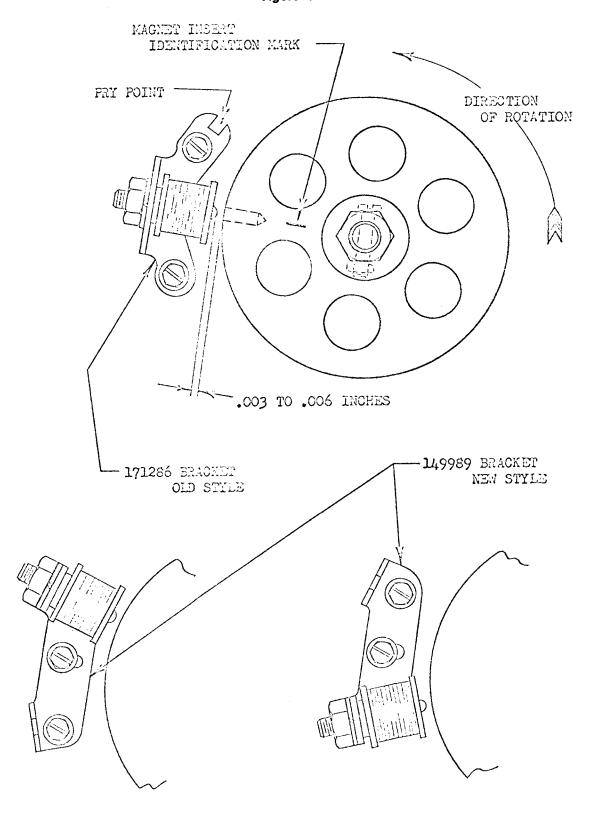
OBJECT: To increase the orientation range of the magnetic pickup coil assembly and provide an orientation overlap of the magnetic pickup coil assembly in respect to the magnetic insert of the flywheel. The flywheel assembly can only be positioned in increments of 90 degrees. The present coil mounting bracket only allows about 80 degrees orientation of the pickup coil.

CHANGE: The TP171285 nut plate and TP171286 coil mounting bracket have been replaced by a TP149990 nut plate and a TP149989 coil mounting bracket.

The new style TP149989 coil mounting bracket has two formed ear sections to which the 261M coil assembly can be mounted and each ear is about 19 degrees from the bracket center line. The pickup coil may be optionally mounted on either of the coil mounting ear sections. The added 19 degree displacement of the coil position will enable establishing an orientation overlap of the pickup coil relative to the insert of the flywheel at either the leading or trailing end of the transmitted signal.

The new style TP149990 nut plate has an over-all length of about 13/16 (.818) inches. The old style TP171285 nut plate has an over-all length of about 1-1/4 (1.251) inches.

Figure 1 illustrates the old and new style brackets. The new style bracket requires the addition of preliminary assembly information to the bulletins and practices which are as follows:

"For units equipped with the TP149989 coil mounting bracket, it may be necessary to mount the pickup coil on either the upper or lower mounting ear to obtain an orientation overlap."

INTERCHANGEABILITY: New and old style brackets and nut plates are not individually interchangeable, but are interchangeable in pairs or sets.

APPLICATION TO APPARATUS IN THE FIELD: Should be incorporated in all apparatus where an extended range may be required to meet specified adjustments or pickup coil orientation requirements.
