SERVICE NOTES

AN/URC-32 - USE OF COUPLER-MONITOR CU-737/URC ACCESSORY

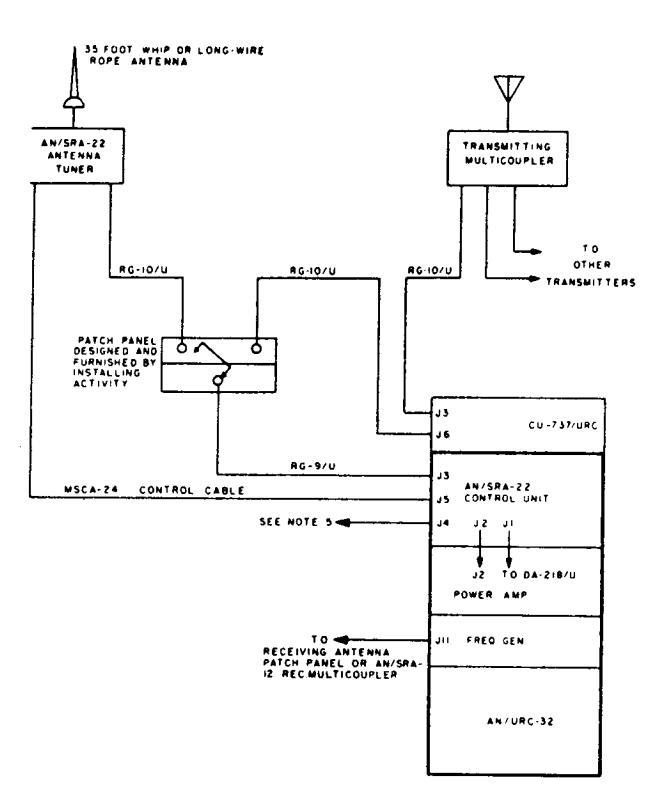
Figure 1. Typical System Interconnection Diagram

Since the CU-737/URC was not originally intended to perform this system function, the equipment modifications as noted on Figure 1 notes must be accomplished. When the AN/SRA-22, CU-737/URC system is used, it is preferable to provide a separate receiving antenna to the AN/ URC-32 receiver antenna input. (518)

1. CU-737/URC

a. Disconnect interval connections to J4 and J5. Assemble cable and connectors to connect J4 and J5 direct.

Remove switch S3, associated wiring and blank-off front panel hole and switch position indicators.

b. Remove antenna relay K1, connector P1 and connect transmission line from patch panel to J6 of the CU-737/URC.

c. From terminal board J8, connect speaker leads 3 and 4 to terminals 3 and 4 of terminal board TBH in the AN/URC-32 junction box. This will provide a local speaker-monitor.

2. AN/URC-32

a. Remove 680 ohm resistor from junction box terminals G5-G6.

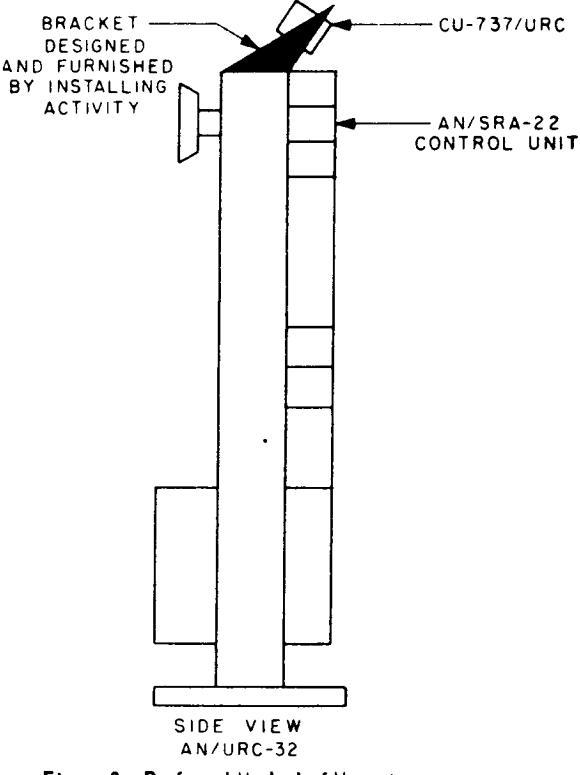
Figure 2. Preferred Method of Mounting

Figure 1 provides the typical system interconnection for this purpose. The control unit for the AN/SRA-22 shall be installed in the AN/URC-32 rack in the space provided and the CU-737/URC shall be located close to the AN/URC-32 for convenience in tuning. Figure 2 indicates the preferred method of mounting, if space permits.

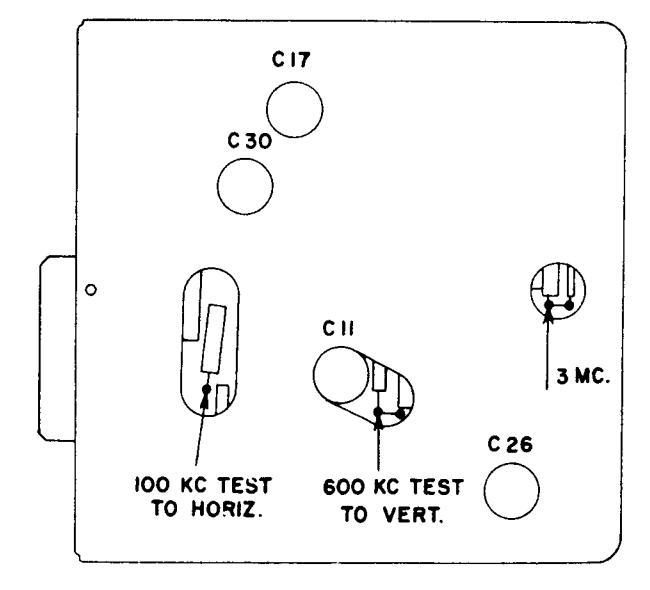
Figure 1. Test Points as Viewed Through Alignment Cover

7. Connect the oscilloscope to the 100-kc. and 600-kc. test points as shown in figure 1. Adjust C17 and C30 for a well-balanced 6-to-1 Lissajous figure with maximum amplitude. Tuning of C17 and C30 will readily show the position at which the best figure display will be seen. Adjust C11 for maximum amplitude of the 6-to-1 figure. Tuning of C26 will cause the figure to run off the scope to the left or right. After doing this, the proper setting of C26 will be apparent. At this setting there will also be a very slight increase in the amplitude of the 6-to-1 figure. If the 6-to-1 figure is obtained, it is known that the 2.4 mc. signal and the 100-kc. signals are present and the above adjustment will have peaked the 2.4-mc. signal.

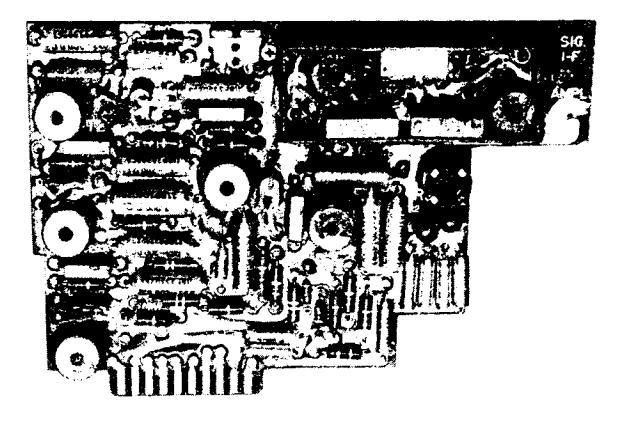
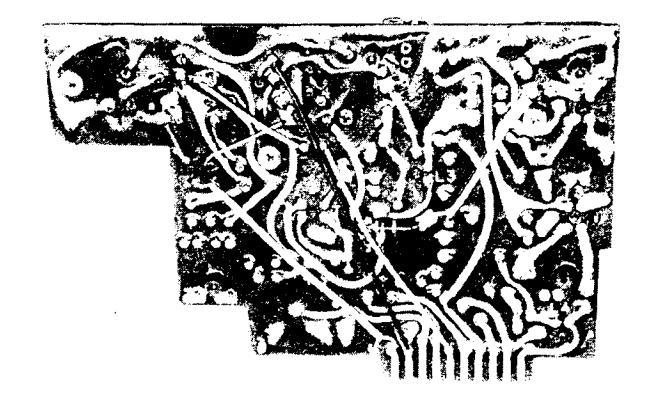
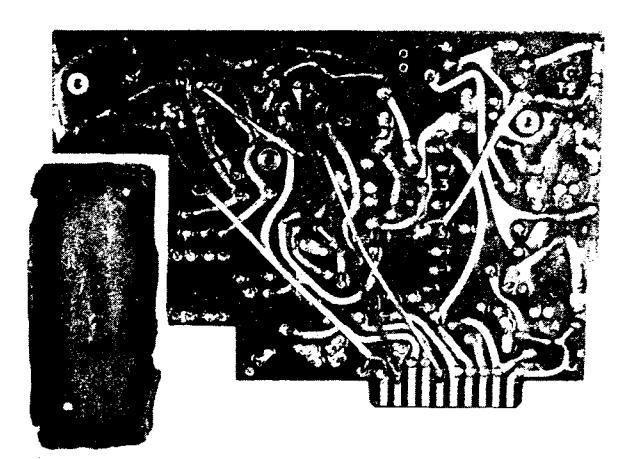
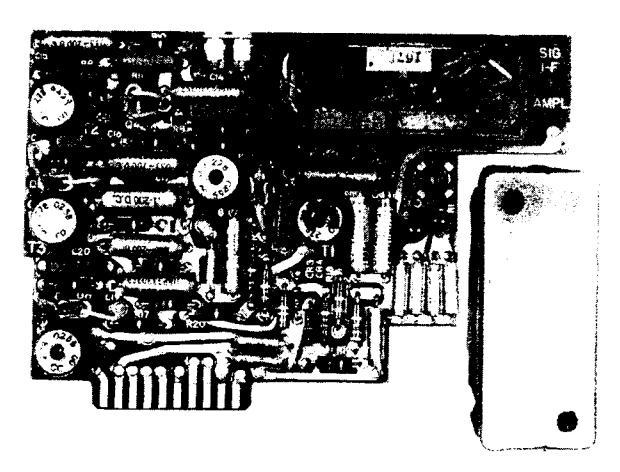
Figure 1

The accompanying illustrations show severe damage to printed circuit boards which never should have occured. An analysis of recent failures has proved conclusively that, had field changes to the AN/URC-32 equipments been accomplished, this damage would not have taken place.

Figures 1,2,3, and 4 show the destruction of the printed circuit boards (Signal IF Board in the Stabilized Master Oscillator Module), caused by the thermostatic switch (AIS1) sticking. If Field Change 1 had been accomplished, the damage probably would not have occurred. (See note below)

Field changes to these equipments have been published and announced repeatedly in successive issues of the EIB. It is strongly recommended that holders of equipments accomplish equipment field changes as soon as they are available.

NOTE: Holders of Models A or B SMOS should turn same in and draw C SMOS. All models A or B are being converted to model C by S. Fran and NORVA Module Repair Facilities as fast as they are received. No A or B are being issued by Supply.

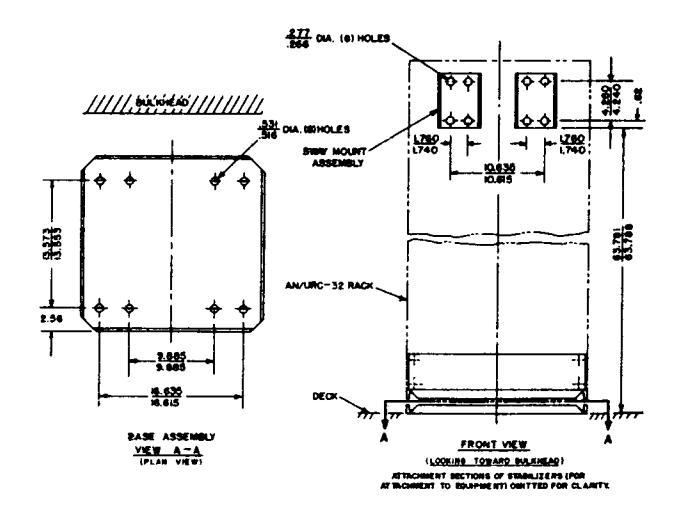
Figure 2. Mounting Hole Location for Earlier AN/URC-32 Version

The major difference in the assemblies is the location of the bolt holes used in installing the equipment. The newer unit requires only 4 bolts in the base assembly and 4 bolts in the sway brace assembly. The earlier units required 8 bolts in each assembly. Figure 1 provides mounting hole locations for the newer assembly. Figure 2 provides mounting hole locations for the earlier AN/URC-32 version.

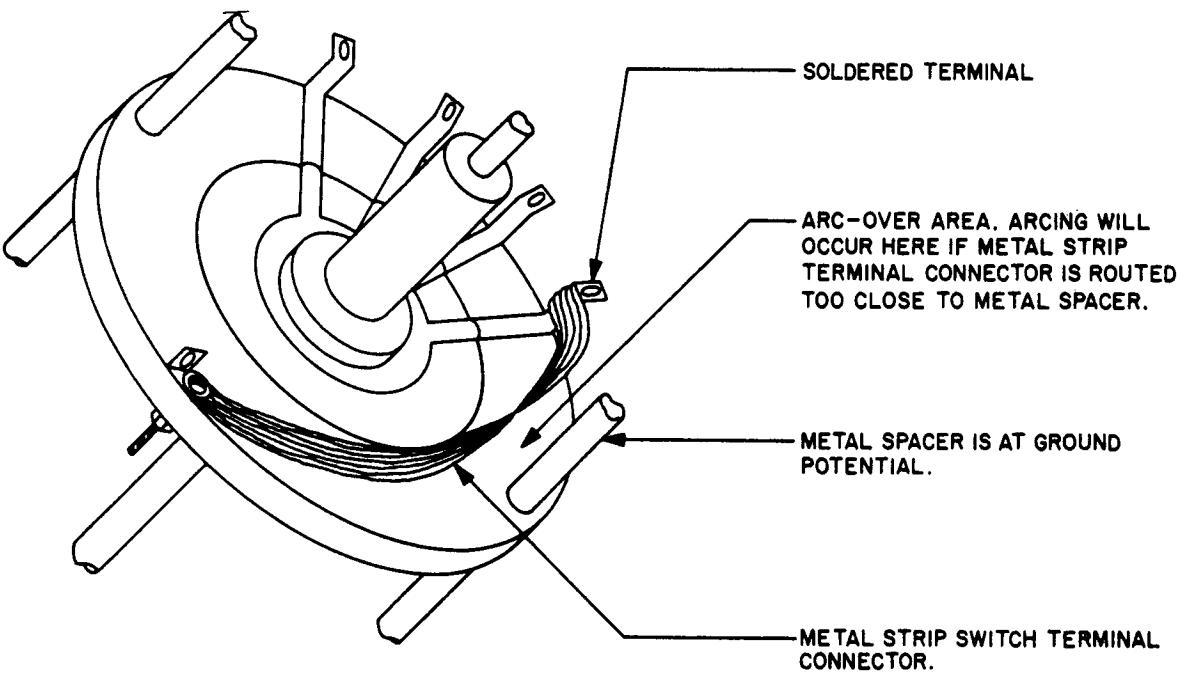
Figure 1. S-6A Section of AM-2061/URT, S-6 and S-5 Switch Assembly

The arc-over was due to the flat metal strip being routed too close to the metal wafer spacer. Investigations by the Naval Ship Engineering Center, Norfolk Division, have revealed that some of these switch sections have the metal strip connector routed as close as 1/16th of an inch to the spacer.

It is recommended that switch section S-6A be examined at the earliest opportunity by maintenance personnel to ensure that the foregoing condition does not exist. If it is found that the flat metal strip is routed too close to the spacer (less than 1/4'') due to the strip being too long, which in turn necessitated a large bend in the strip in order to make the connection to the soldered terminal, the strip should then be un-soldered from the solder terminal and shortened so as to obtain 1/4'' to 5/16'' clearance between the strip and spacer, then resolder the strip to the solder terminal. In some instances the strip can be pushed away from the spacer to obtain the desired clearance. This is permissable as long as a smooth, even bend or curve can be maintained over the length of the connector strip; otherwise, unsolder and shorten, as above.
