SERVICE NOTES

AN/URC-32 - USE OF COUPLER-MONITOR CU-737/URC ACCESSORY

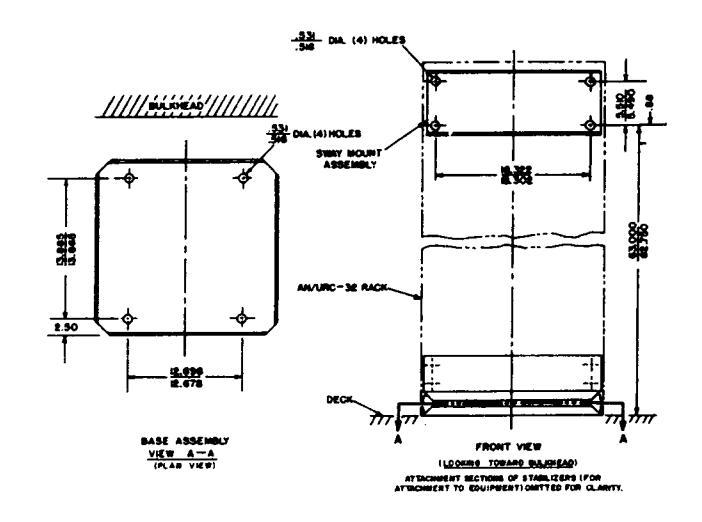
The major difference in the assemblies is the location of the bolt holes used in installing the equipment. The newer unit requires only 4 bolts in the base assembly and 4 bolts in the sway brace assembly. The earlier units required 8 bolts in each assembly. Figure 1 provides mounting hole locations for the newer assembly. Figure 2 provides mounting hole locations for the earlier AN/URC-32 version.
