TELETYPE CORPORATION CHICAGO, ILLINOIS, U.S.A.

EE-525 ISSUE 1 JANUARY, 1946

CHANGES AND ADDITIONS TO PARTS BULLETINS

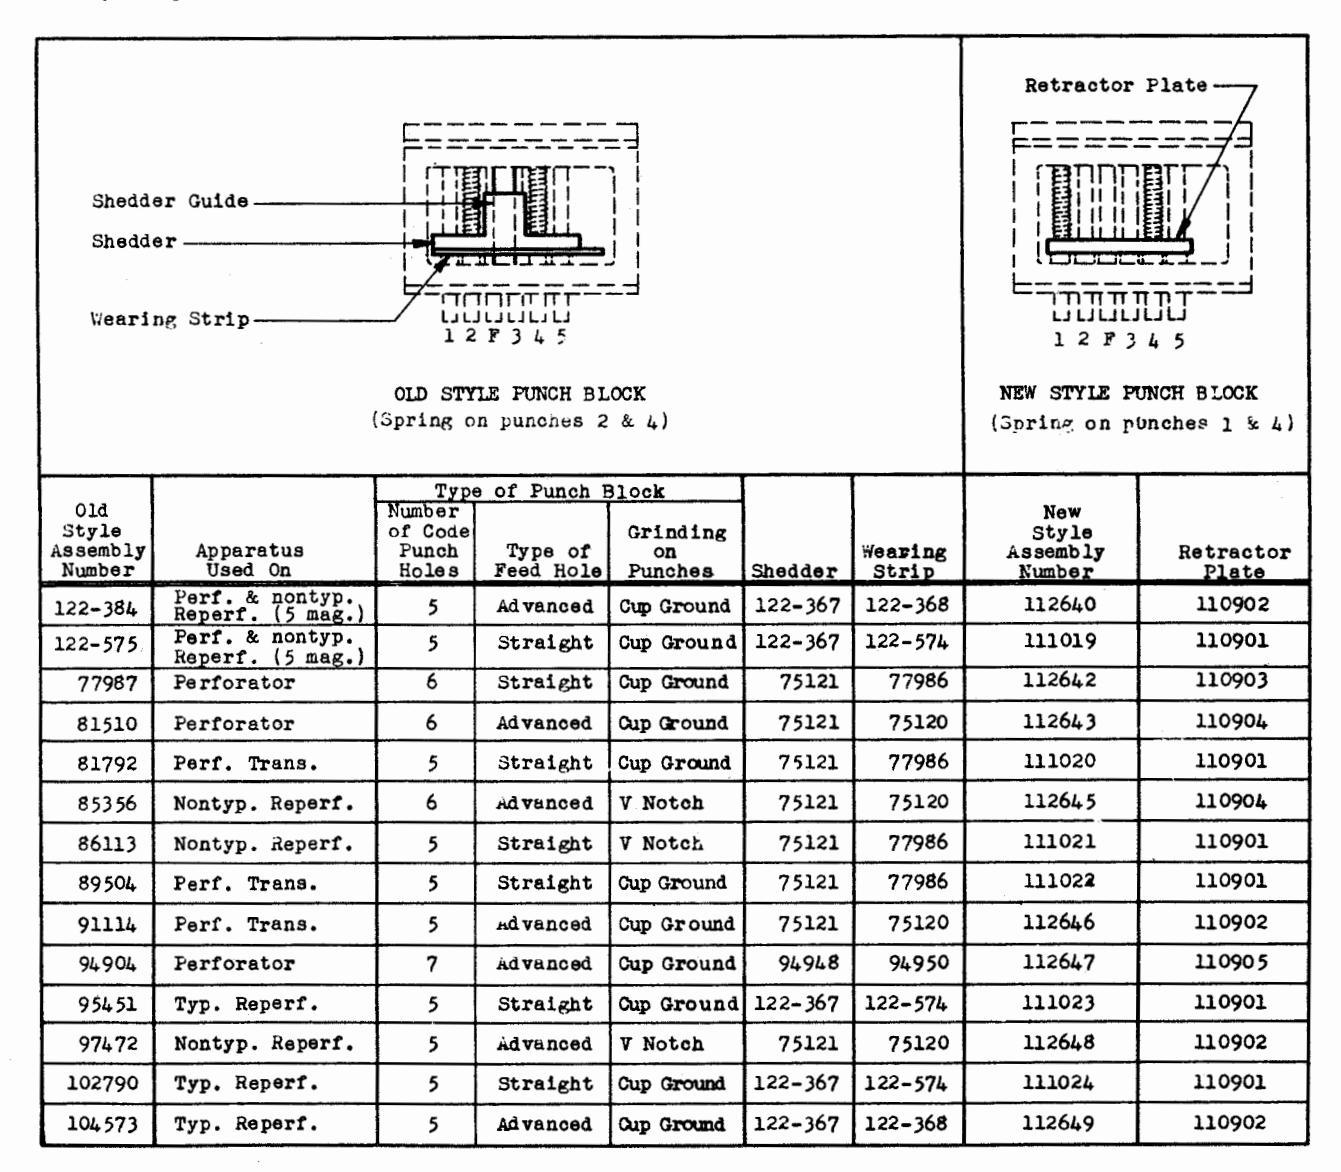
The sketches below illustrate the difference between the old and new style assemblies, and it should be noted that the shedder and wearing strip are replaced by a retractor plate, and the shedder guides are not used. The shedder and wearing strip are no longer being furnished. When it is desired to replace a shedder or wearing strip, a retractor plate should be ordered instead.

The chart below may be used to determine the new style punch block assembly number which replaces an old style, and which retractor plate must be ordered to replace the old style shedder, and/or wearing strip.

The punch block assemblies shown in the above bulletins have been redesigned and assigned new assembly numbers. Old style punch block assemblies are no longer furnished. On orders for old style blocks, new style assemblies which are fully interchangeable with the old style will be furnished.
